Inspection Report
Minerals Regulatory Program
Report Date: May 16, 2005

Mine Name: Italian Tan
Operator or Permittee Name:
Quality Building Stone
Permittee Mailing Address:
933 W. 14730 S., Bluffdale, Utah 84065

Permit number: S/007/038
Inspection Date: May 5, 2005

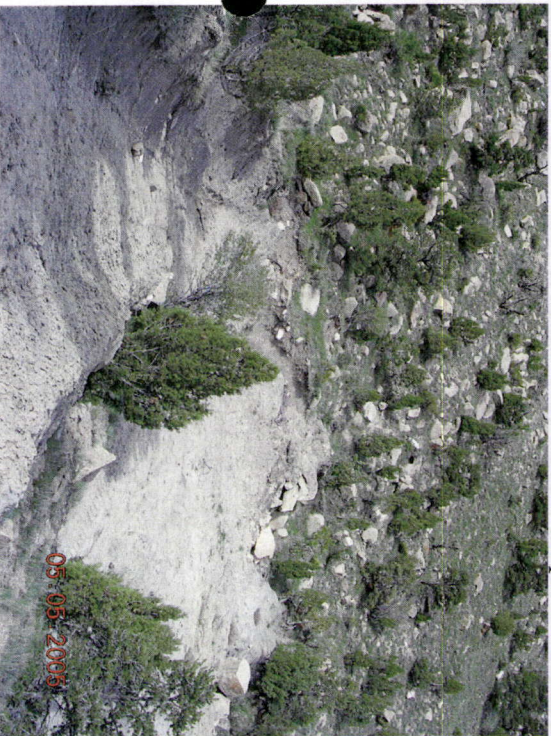
Photo 1. Road going up the side of the hill.

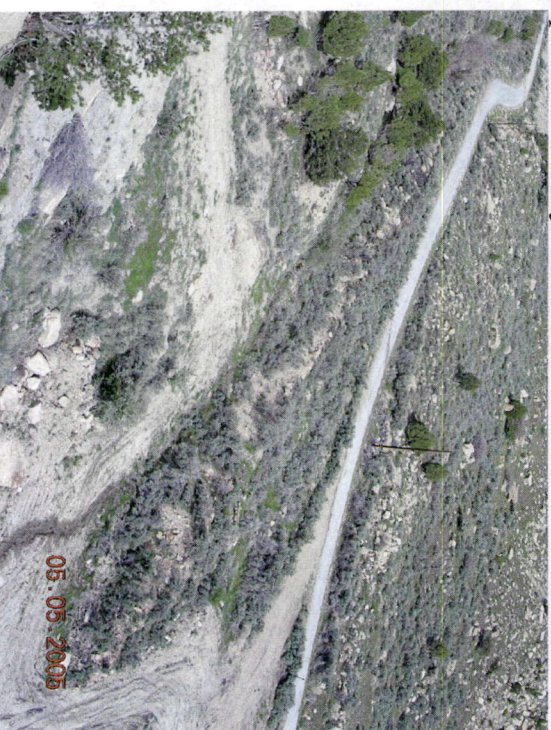
There was water running in Hardscrabble Creek. This is the first time since I started visiting this area in 1992 that I have seen running water in this creek.

Photo 3. Note Hardscrabble Creek in the bottom right portion of the picture.

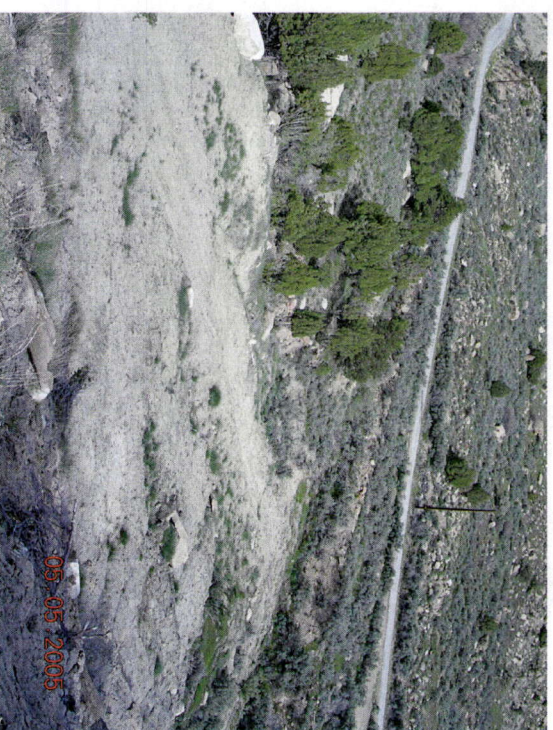
Photo 4. This shows the largest part of the mine disturbance.

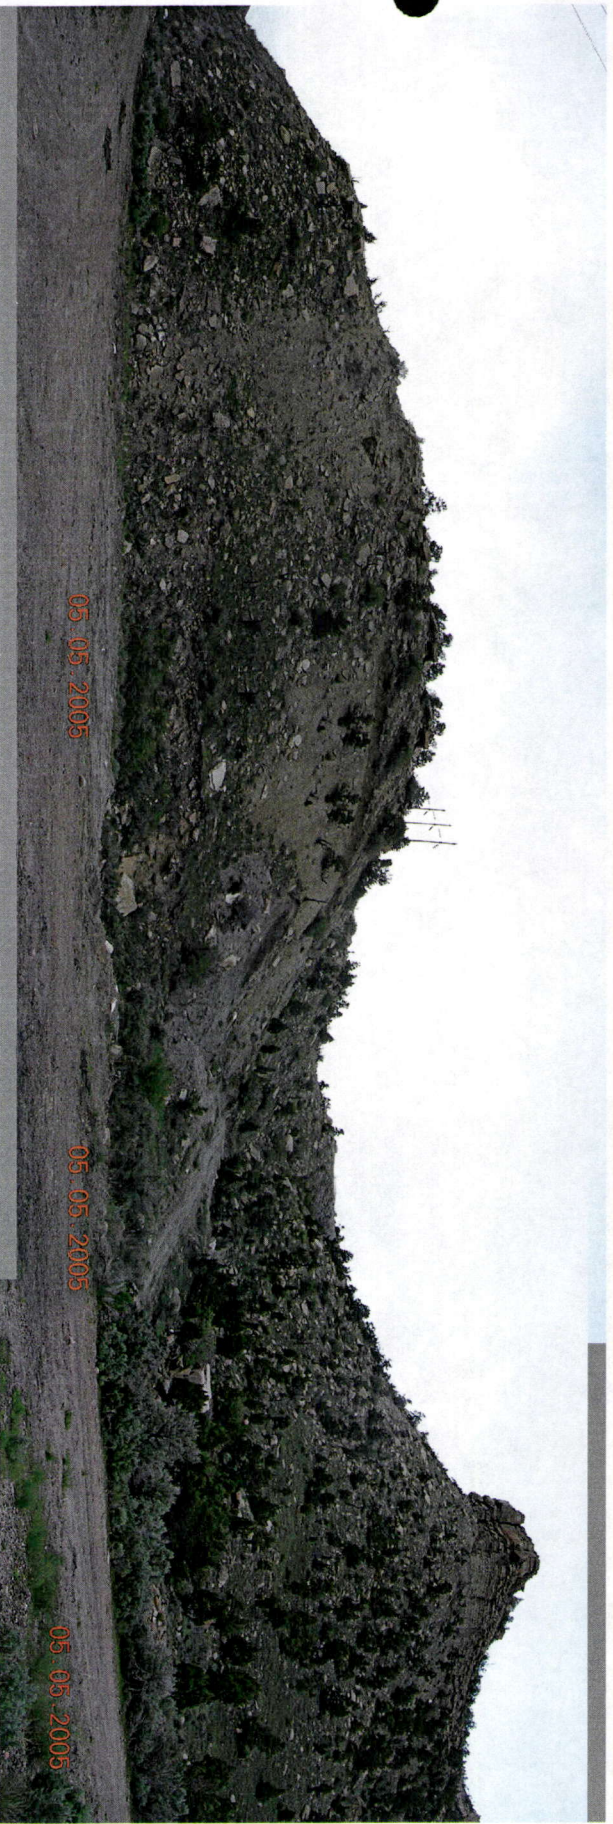
Photo 5. Panorama of the mine site.

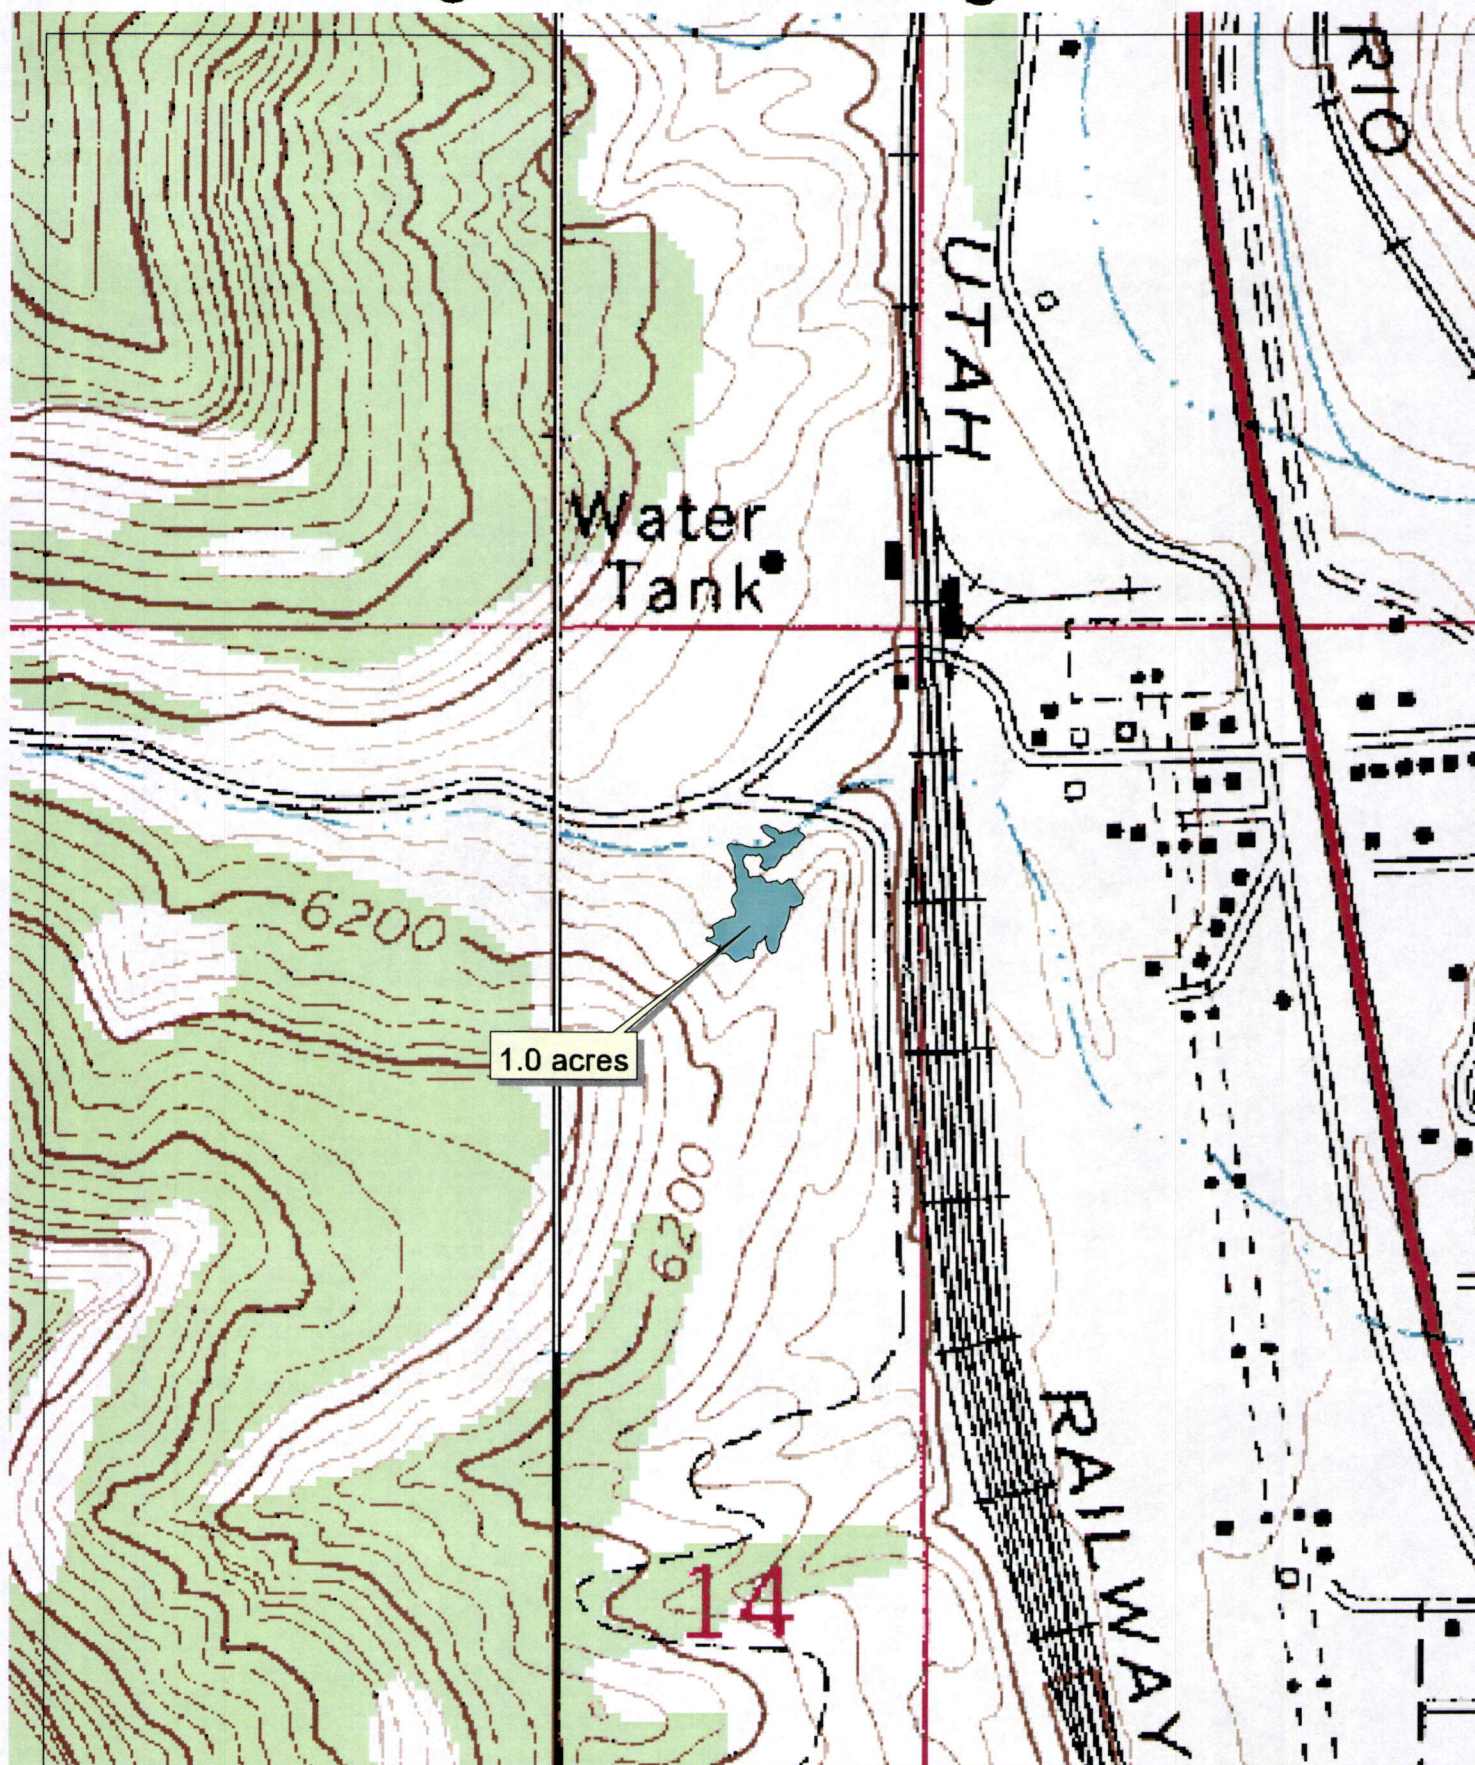
I took GPS readings around the perimeter of the disturbed area, and a copy of the map is attached to this report. The current disturbed area is 1.0 acres.
